TROJAN HORSE [REDACTED]

NPIC/CSD 548/65

VINH COMPLEX
NORTH VIETNAM
1840N 10540E
[REDACTED]

VINH COMPLEX

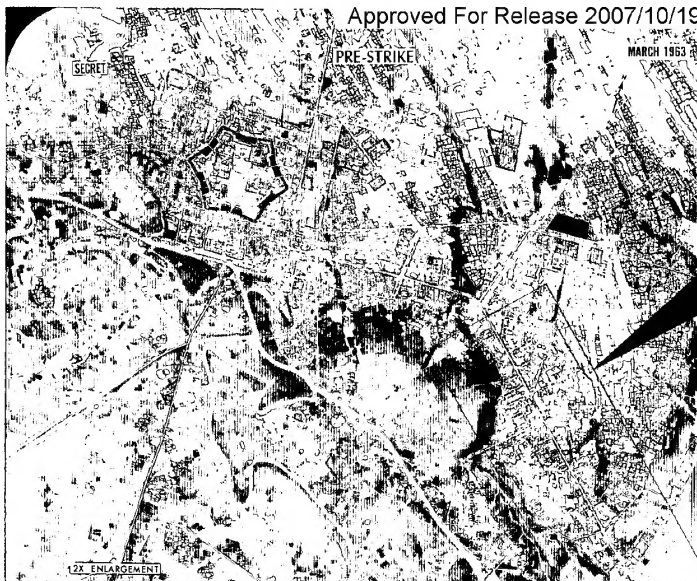
1. PRE-STRIKE PHOTOGRAPHY OF MARCH, 1963 REVEALS VINH COMPLEX.

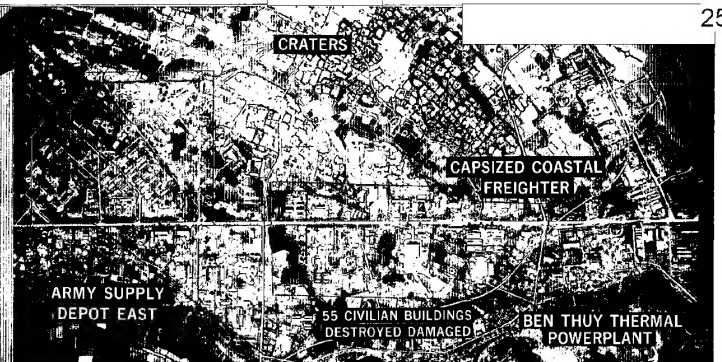
[REDACTED] REVEALS THIRTY STORAGE/WAREHOUSE AND SHIP REPAIR BUILDINGS HAVE BEEN DESTROYED OR DAMAGED AT BEN THUY PORT FACILITY. NUMEROUS SUPPORT BUILDINGS IN THE FACILITY HAVE ALSO BEEN DESTROYED OR DAMAGED. A CAPSIZED COASTAL FREIGHTER IS OBSERVED NEAR THE PIERS.

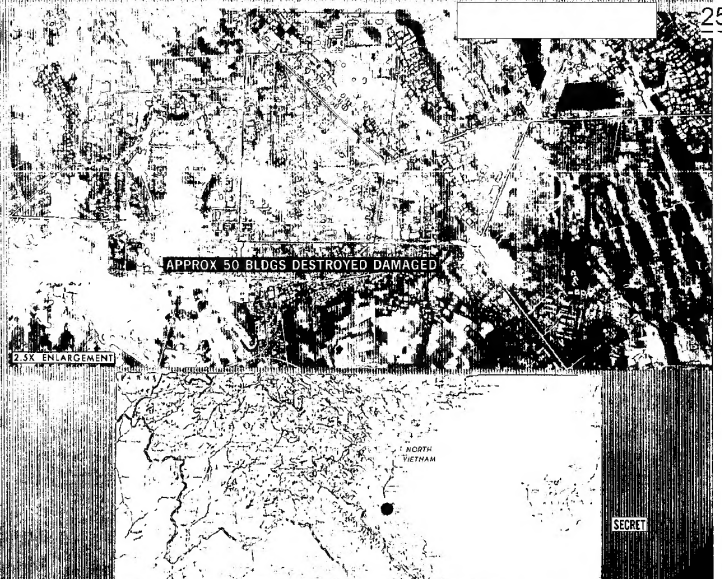
[REDACTED] REVEALS ELEVEN LARGE STORAGE, EIGHT ADMINISTRATION, TWO MESSHALLS, TWENTY-TWO BARRACKS, AND NUMEROUS SMALL SUPPORT BUILDINGS HAVE BEEN DESTROYED OR DAMAGED AT VINH ARMY BARRACKS AND SUPPLY DEPOT. BEN THUY THERMAL POWER PLANT IS INOPERABLE. THE TRANSFORMER YARD AND NUMEROUS SMALL SUPPORT BUILDINGS IN THE TARGET AREA HAVE BEEN DESTROYED AND THE BOILER AND GENERATOR ROOMS HAVE BEEN SEVERELY DAMAGED. FIFTY-FIVE CIVILIAN STRUCTURES ARE DESTROYED/DAMAGED. ADDITIONAL PROBABLE SMALL CIVILIAN HOUSING UNITS HAVE BEEN DESTROYED ALTHOUGH AN ACCURATE ASSESSMENT IS IMPRACTICAL WITH AVAILABLE PHOTOGRAPHY.
